THE INCIDENTS OF BRIDGES AND ROADS AT PLAIN OF REEDS - VIETNAM AND SUGGESTED SOLUTIONS

NGUYEN THANH NGUYEN

ABSTRACT

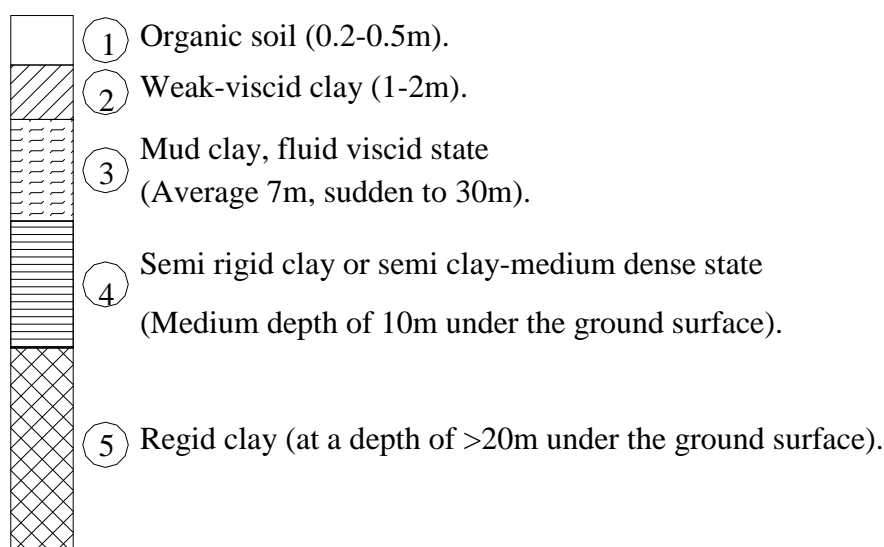
Figure 1. Typical geological section of Plain

Plain of Reeds was shaped in Quarternary (Qiv). Its geologic feature is based on two units of sediment, from Pleistocene and Holocene epoch and also the intermediate stage of post - Pleistocene. The complete formation of the Plain began after post-Pleistocene, about 8,000 years ago. In the whole area, the sediment layer of ancient alluvium is covered with new material of Holocene sediment. Therefore, the old alluvium mounds and arenosols are found alternate with new alluvium fields. Under the effect of natural factors, weathering, and biochemical processes, many soil groups were founded: old alluvium, arenosols, fluvisols, thionisols, peat, new alluvium... Geological feature is the weak soil (new alluvium) that situates near the earth's surface; this soil layer occasionally changes its thickness (see figure 1), especially at places where there are old river-beds, mires, bogs... (Ta *et al*, 2002; Tamura *et al*, 2012). The sudden change within a short distance that is not discovered by surveyors is the reason of many incidents.

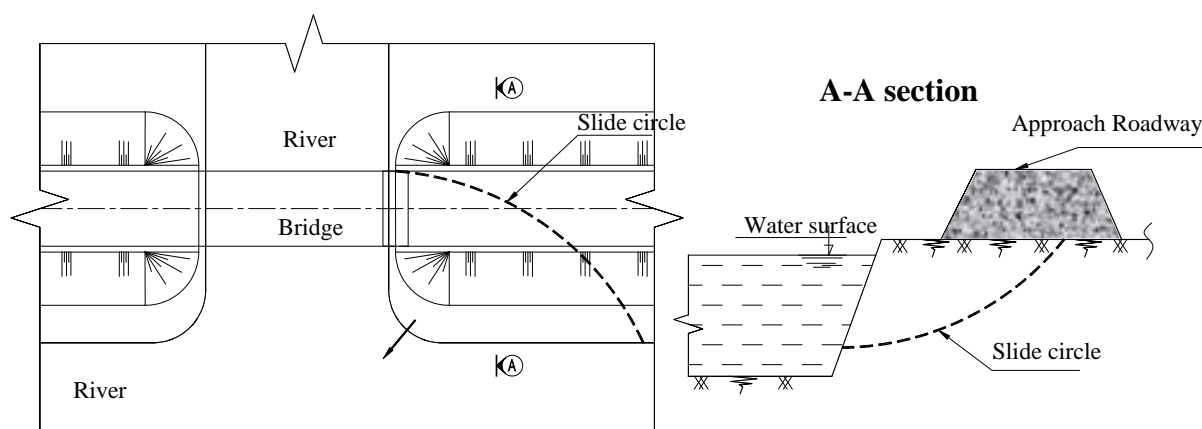
Figure 2. Slide circle of approach roadway

➤ In the Plain, because there are many rivers and canals, the density of bridges is very high; in average, the distance of two bridges is 1km. The bridges are usually posed at confluence; because of weak soil, the high approach roadway causes easily two demension land slide (see figure 2). While, the Plain is an anual high flood area of Mekong Delta, so the approach road ways are always built much more higher than the natural earth's surface to assure clearance of bridge span and flood level; this is the addition cause of construction incidents.

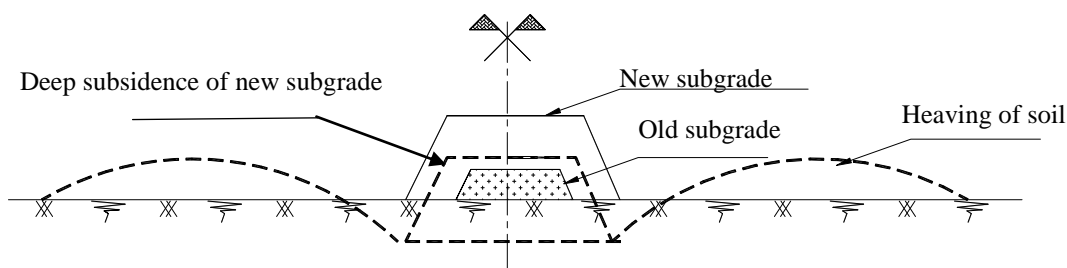
Figure 3. Deep subsidence of subgrade with heaving of soil

- Incident description: the road was upgraded from the old construction which was built hundred years ago, and there was no elaborate geological survey. The medium elevation of old road bed surface was +1.5, the structure of road was graded aggregate, pavement width 4m, subgrade width of 6m. The new road had +4 high level, graded aggregate pavement, 6m of pavement and 9 m width of subgrade. After 6 months of finish, the subgrade subsidence was 1m and 1 year later it reached 1.5m. The incident occurred on a distance of 200m and this hindered the traffic, especially in the flood season of 2000-2003 (see figure 3). The resurvey shows that the layer of mud clay layer is very thick and the added height of fill is 2.5m.

- Treatment measure: after the incident, the geological survey discovered an old river bed in this position and the layer of weak soil was over 30m with low mechanical indicator (c, ϕ). Two recovery options were proposed.

➤ Option 2: it is needed to build 'anti pressure fill' in two sides of incident road (each side 20m, elevation +3). The method accepted subsidence and added fill. This way had low cost but the recovery time was rather long, and it had to accept traffic inconvenience of frequent fill work (see figure 4).

- Treatment result: because of many reasons, especially of cost, the 'anti pressure fill' was chosen. After about 1 year of treatment, the subsidence diminished gradually and after 2 years, the construction was stable and well exploited.

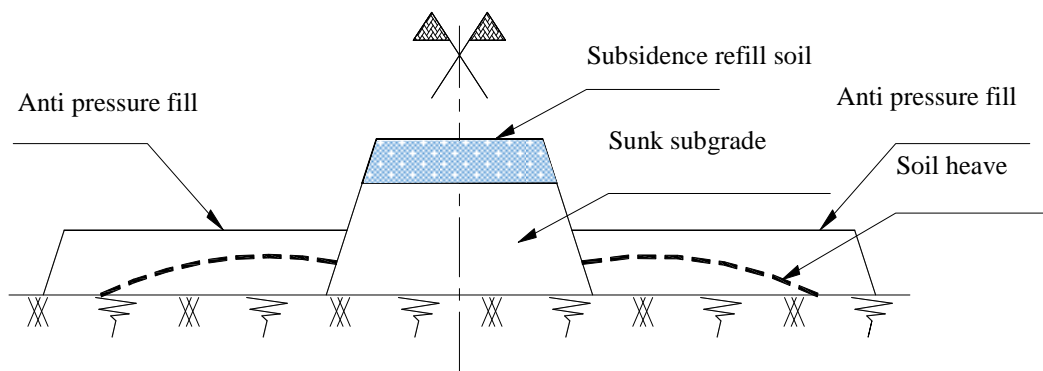
Figure 4. Deep subsidence subgrade treatment

- Description: the road was designed as new construction and situated far of river, the width of subgrade and pavement was 9m and 6m; this area has weak soil with peat and mud clay, its thickness is about 20m. During construction, the fill caused subsidence and the soil heaved two sides of road, the volume of subgrade work increased double to previous calculation. After one year of

accomplishment, the subgrade sank more than one meter.

- Treatment method: because of finance difficulty, 'anti pressure fill' method was used. They filled by soil for 20m each side and the elevation was +2 to the natural land level. When the subgrade sank about 0.4 meter, they continued to fill to assure the pavement level for traffic and anti-flood. After one year of treatment, the subgrade became stable and the construction was exploited normally (see figure 4).

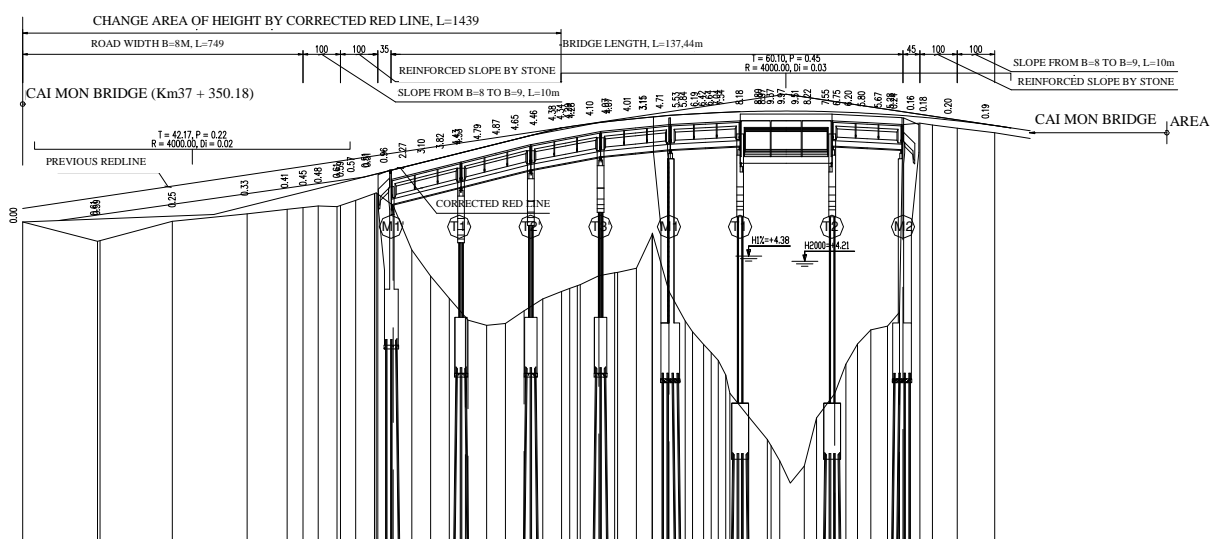
- Incident description: the bridge was designed with these details: width of 10m, prestressed reinforced concrete beams, reinforced concrete pile foundation. It had three spans: 18.6+24.54+18.6. The medium of approach way embankment high was 5m; the foundation of approach way embankment was reinforced in an area of 16x22m by cement earth piles ($\Phi 600$, L12m) with distance of 1.3m. The position of bridge was at the cross of Cai Mon River and 79 Canal. When they filled the embankment to the K98 sand layer (about 4m above natural land level), the M1 embankment slid into the 79 Canal of 75m in length, and the width was more than 20m.

- Reason of the incident: the thickness of weak soil is big. In this area, the clay mud layer is 9m medium and at M1 abutment, it increases to 20m. Besides, the fill of approach way was more than 5m to the existing land level, the construction was near river bank and at the cross of river and canal. The later survey showed that the bed of the canal was deepened more than 2m and this was not updated in the design. Along with the above reasons, the designers did not calculate land

- After analysis of economy and technique, the proposal of four spans extension was selected. The decision was based on cost effectiveness, design, work condition and old slide effect when they continued to reload the approach road way. The bridge was extended 4 spans of 18.6m. The construction treatment finished in 2015 and it is now in good condition (see figure 9-11).

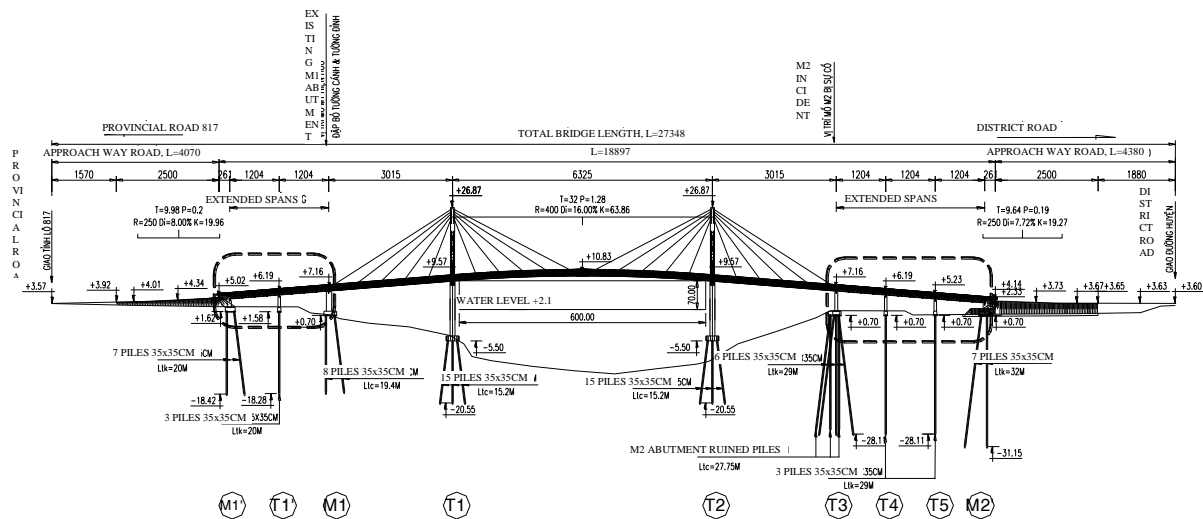
Figure 12. Section of Binh Phong Thanh bridge treatment

- The Binh Phong Thanh bridge is a suspension bridge built across Vam Co river. At first, the bridge had 4m width in plate steel, three spans (30-60-30m); two abutments were planned as pile and plank retaining walls for approach road ways. When they built abutment and load A embankment to level +5, it caused a slide circle with its width of 15m to the land. The land slide brought about the overturn of A abutment, the retaining wall

inclined to approach way. The cause was determined by many reasons: load of high embankment, near river position of abutment, thick layer of weak soil, design engineers did not calculate land slide, and there was no careful geologic survey.

- The solution: the bridge was extended two spans of 12m for B abutment (it had not yet incident), three spans of 12m for A abutment, the level of embankment is +4 (see figure 12-13). After reconstruction, the bridge was exploited in late 2016.

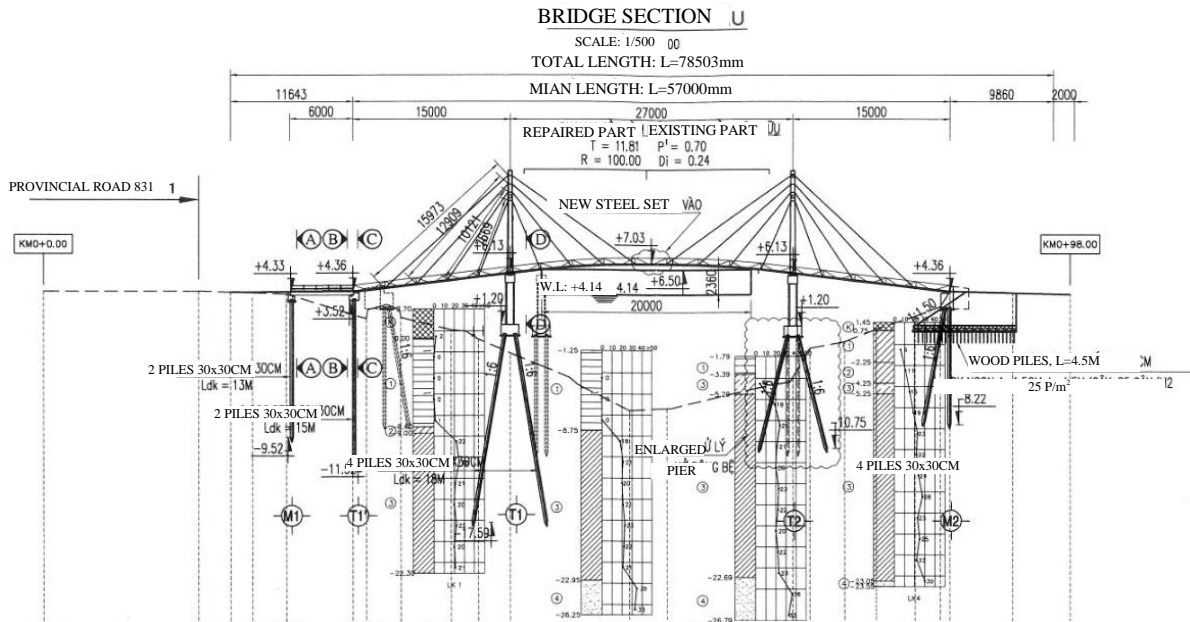
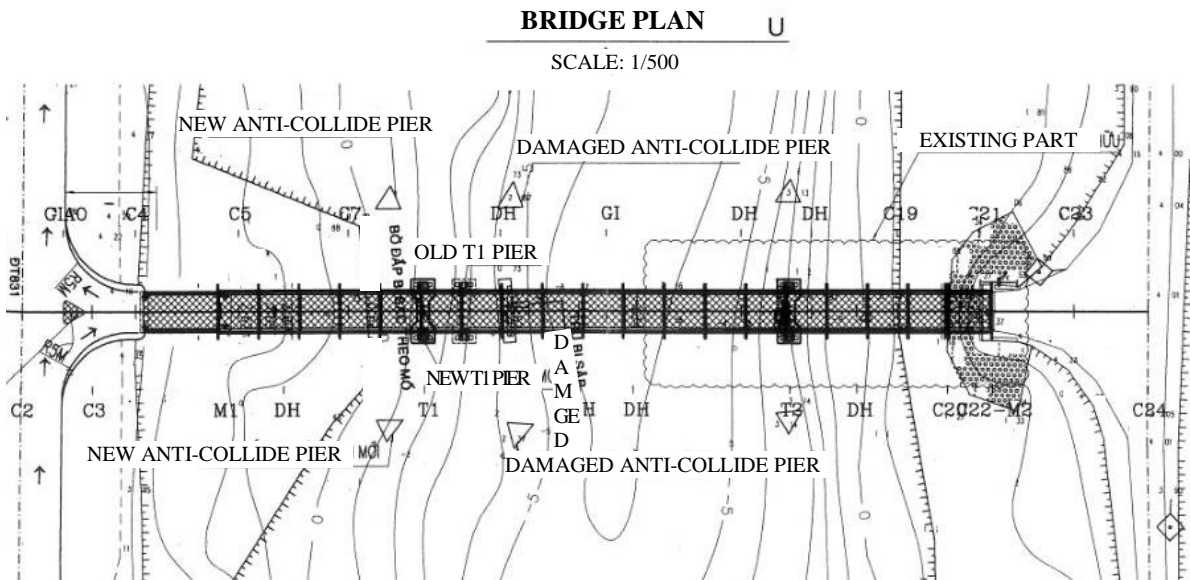
geographic survey. This situation has a thick layer of mud clay and at M1 abutment (along Provincial road 831) there was a land slide five years before. The bridge was unfinished then at M1 abutment, there was a land slide along Provincial road 831, the length was 50m, width of 10m. The pressure of land slide overturned the M1 abutment, the retaining wall inclined to approach way, the T1 pier also inclined.

there was a thick mud clay layer at bridge, along with the high fill level of Provincial road 831 and approach road way, near the canal. At construction, it occurred a land slide years ago and engineers did not calculate land

- Treatment way: they rebuilt T1 pier, built new T'1 pier, new M1 abutment, extended a span of 3m to connect T'1 pier and new M1 abutment (see figure 14-16).
