**APPLICATION OF GLASS FIBRE-REINFORCED HIGH STRENGTH SELF-COMPACTING MORTAR FOR REHABILITATING MARINE STRUCTURES****Nguyen Viet Duc<sup>1</sup>**

**Abstract:** *Maintenance and rehabilitation of marine structure is currently indispensable in Vietnam to prolong the service life instead of re-building with a very high cost that cannot be done in the short term. This paper focuses on the rehabilitation work of a beam structure by using glass fiber-reinforced high strength self-compacting mortar or SCM. The process was carried out by simply pouring the fresh SCM onto the surface of the beam that needs to be rehabilitated. The third-point bending test has been used for the evaluation of rehabilitating effectiveness. The experimental results showed that the flexural strength of the rehabilitated beam with SCM application has improved 22% higher than that of the non-rehabilitated ones. In case of the rehabilitated beams that have cracked before, they still sustained a certain sagging and hogging moment after rehabilitation. Visual observation on the cross-section of the rehabilitated beam after the third-point bending test indicated that there was no delamination or crack between layers

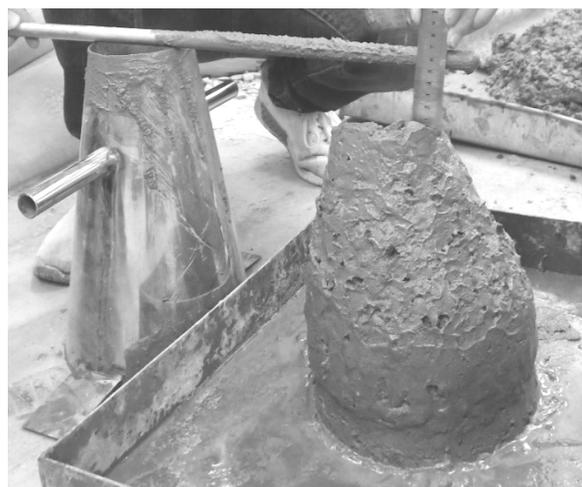
*Figure 1. Slump-flow test on SCM mixture at fresh state*

In order to prepare a reference beam element or the structure needs to be rehabilitated, conventional concrete of strength class 30MPa was chosen to be proportioned. The mix design of this concrete was carried out by using the Bolomay-Skramtaep method. Water content was adjusted by mean of the slump test, as shown in Figure 1, and the final mix proportion is provided in Table 7.

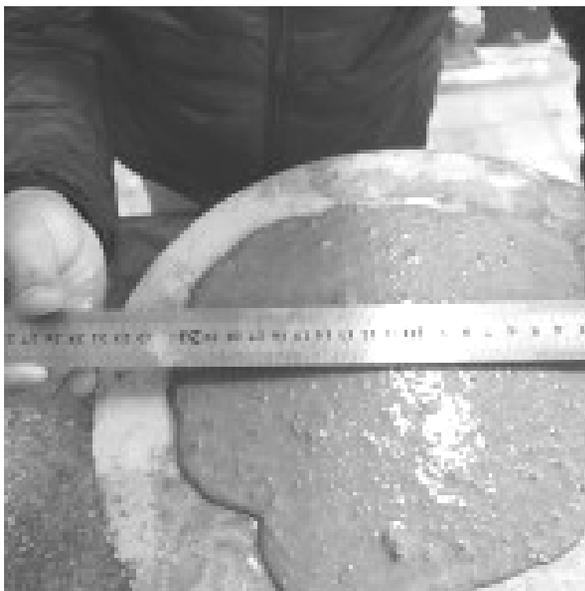
*Figure 2. Slump-flow test on SCM mixture*

Besides, several guidelines on SCC from EFNARC have been taken into consideration (EFNARC, 2002, 2006). The detailed steps for mix design are described elsewhere in (Ngo, 2020). Some “trial-and-error” were involved to justify the slump flow of 20cm conforming to

the standard TCVN 9204:2012, as shown in Figure 2, for the mix proportion of SCM with glass fiber. Eventually, the SCM mix used in this study can be seen in Table 8.

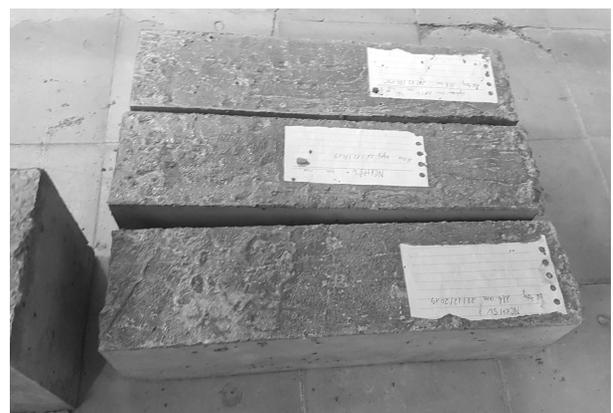
*Figure 3. Conventional concrete prism specimen after standard curing*

Since the concrete is conventional, it needs to vibrate during the placement into the mould.

After casting, the specimens were kept in the laboratory for 24 hours, then they were removed from the moulds and cured under the standard condition ( $T=20\pm 2^{\circ}\text{C}$ ;  $W>95\%$ ) in the curing chamber up to the testing date, as shown in Figure 3.

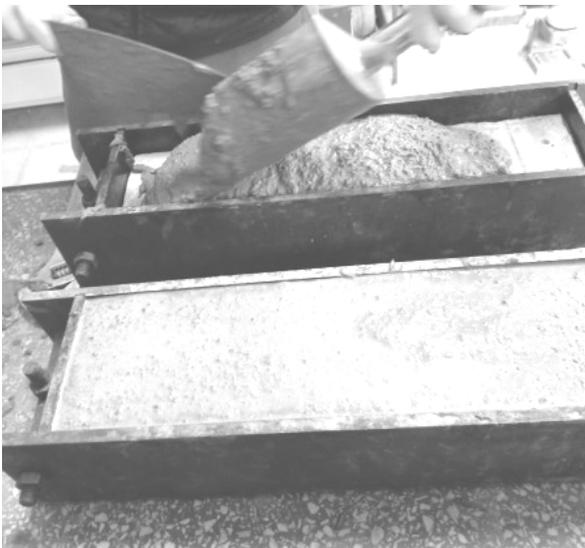
Figure 4. Pouring SCM onto conventional concrete beam surface to rehabilitate

At the age of 28 days, the five prism specimens ( $70\times 100\times 400\text{ mm}^3$ ) of conventional concrete were taken out of the curing chamber, and two of them were subjected to third-point bending up to failure. Afterward, all of them were placed again into the metallic moulds of  $100\times 100\times 400\text{ mm}^3$ , and fresh SCM was poured directly onto the beam surface without any rehabilitation treatment, as shown in Figure 4. The SCM filled fully the mould, which means SCM thickness is 30 mm. These specimens were left in the moulds for 24h, then they were removed from the moulds and placed into the curing chamber up to the testing date.

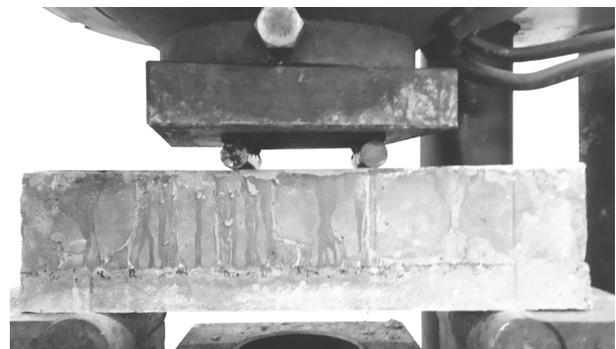
Figure 5. Rehabilitated beam subject to third-point bending test

Apart from the compression test, abrasion test, waterproof test for the determination of hardened properties, the third-point bending test was the main one used for the analysis of rehabilitation effect. After SCM application 28 days, the rehabilitated beams were subjected to

a bending test to define flexural strength, as illustrated in Figure 5. In fact, in the practical rehabilitation, SCM can be applied on the top or at the bottom, wherever it is needed, of the beam in operation. However, when the beam is on the bending test, there is a sagging and hogging moment in beam, the bottom layer is under tension and the top layer is under compression. Since SCM works well on tension much better than conventional concrete due to the addition of fiber, thus the rehabilitated beam was placed to bending test so that the SCM layer was at the bottom to improve the efficient use of costly SCM.

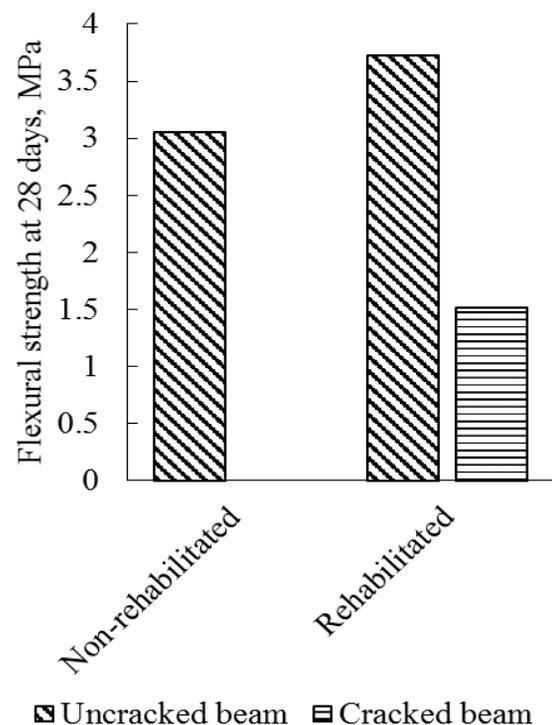
Figure 6. Average result of flexural strength of non-rehabilitated and rehabilitated beams under third-point bending

Figure 6 shows an average result of flexural strength of non-rehabilitated and rehabilitated beams under third-point bending. It is observed that flexural strength of rehabilitated beam with SCM application has improved 22% higher than that of non-rehabilitated one.

Moreover, Table 11 and Figure 6 also reveal the results of the flexural strength of

rehabilitated beam, which has been cracked or broken into pieces before rehabilitation due to concrete brittleness (Neville, 2002). It is noteworthy that after rehabilitation this broken beam still has carried more load. This proves the efficiency of SCM application for the rehabilitation, even in a severe case of crack appearance in the marine structure.

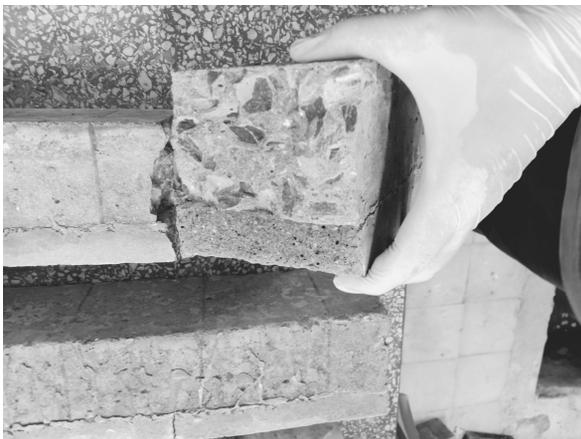
*Figure 7. Rehabilitated beam cross-section after third-point bending test*

Visual observation on rehabilitated beam cross-section after the third-point bending test, as shown in Figure 7, depicts that there is no delamination or crack between conventional concrete and SCM, even though there was a cold-joint, as SCM was cast onto the conventional concrete when it has hardened. Yet, there is no difference between cross-sections of rehabilitated and non-rehabilitated beam, as shown in Figure 8, in terms of failure mode. In case of a cracked beam before rehabilitation, the rehabilitated beam failed at the same crack that has been appeared previously.

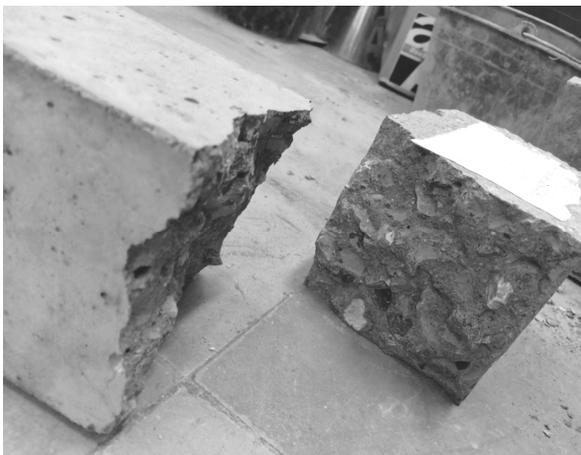
*Figure 8. Non-rehabilitated beam cross-section after third-point bending test*
