Comparative study on the surface treatment for marine structure rehabilitation with glass Fiber-Reinforced high strength Self-Compacting mortar

Nguyen Viet Duc¹

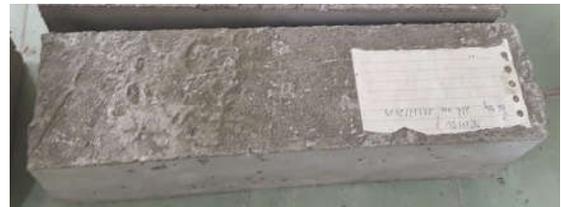
Three rehabilitation methods in terms of surface treatment including as-cast surface, surface prepared with steel brush and surface with hole-connector are involved in this study. The as-cast surface, as shown in Figure 1, implies that the surface is left untreated as original upon casting SCM for rehabilitation procedure.

Figure 1. As-cast surface

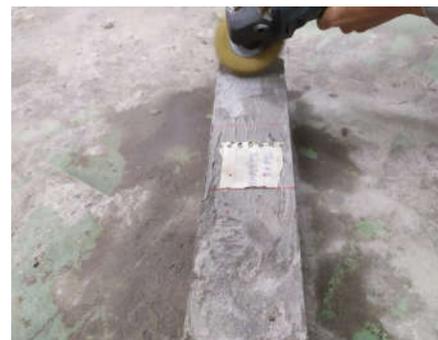
The second method is to make the surface smoother by using a steel brush, as shown in Figure 2. The steel brush seems to remove 1-2 mm depth of mortar on the surface of the structure that needs to be rehabilitated.

a) Grinding with steel brush

b) After surface treatment

Figure 2. Surface prepared with steel brush

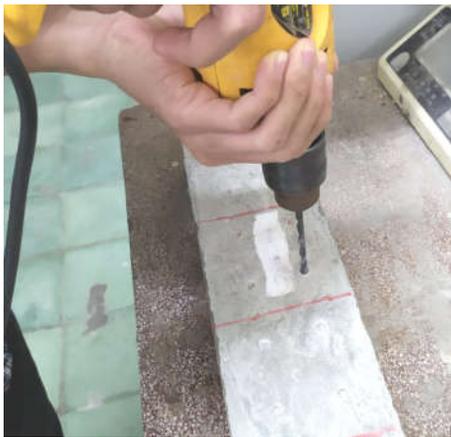
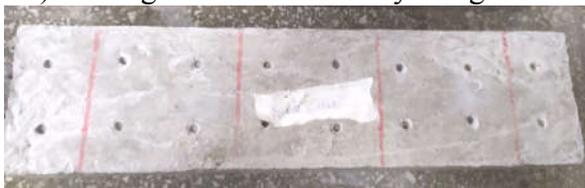
On the other hand, the surface with hole-connector, as a name, presents a series of holes, which are obtained by using a drill, as shown in Figure 3. The hole has 5 mm diameter and 5 mm depth. The distance from one to another is 50 mm and to the edge is 25 mm. The holes make the SCM seems to penetrate into the structure needs to be rehabilitated, which in turn results in a good connection one to another.

a) Making a series of holes by using a drill

b) After surface treatment

Figure 3. Surface with hole-connector

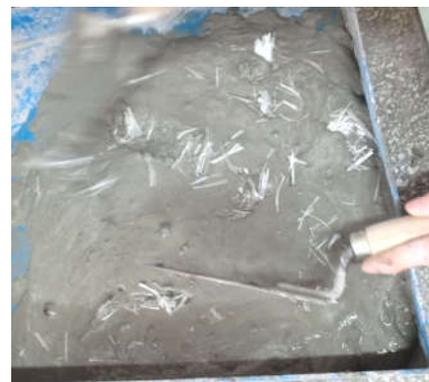
Once there are available the beams that need to be rehabilitated and they are all settled into the moulds, the rehabilitation procedure starts with SCM preparation, as shown in Figure 5. SCM is then poured on the top surface of the beam that needs to be rehabilitated ($400 \times 100 \times 70 \text{ mm}^3$) to make a new one with a dimension of $400 \times 100 \times 100 \text{ mm}^3$, as can be observed in Figure 6. Besides, for the comparative study, the reference beam made of conventional concrete still has a dimension of 400 mm length, 100 mm width and 100 mm height.

Figure 5. SCM preparation

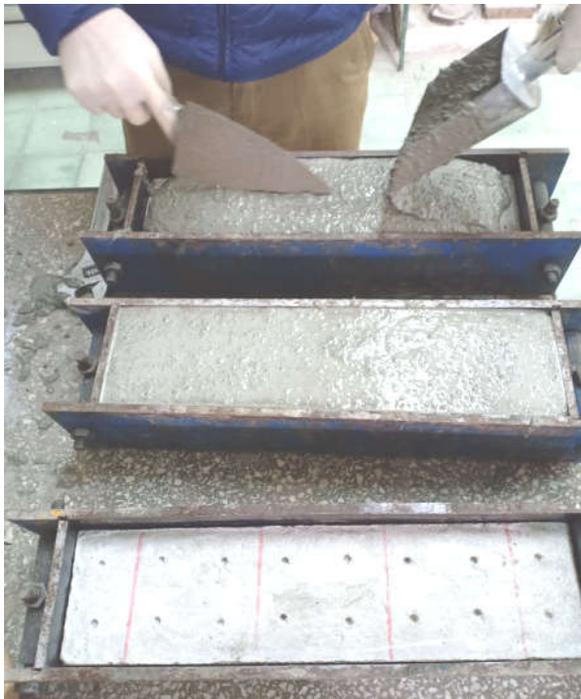
Figure 6. SCM casting for rehabilitation

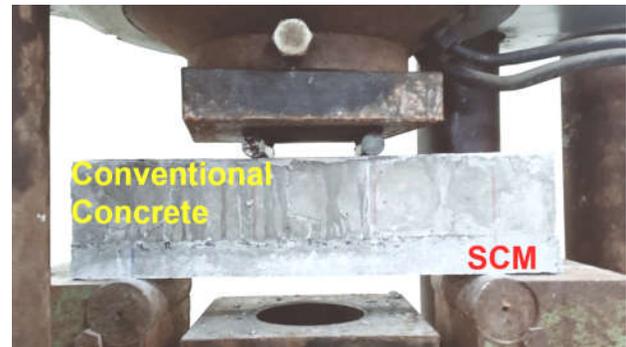
After the rehabilitation procedure 28 days, the reference and rehabilitated beams were subjected to bending test to define flexural strength, as illustrated in Figure 7. The third-point bending test is used with a span length of 300 mm and the distance between load application points is 100 mm.

Figure 7. Third-point bending test

In fact, in the practical rehabilitation, SCM can be applied on the top or at the bottom, wherever it is needed, of the beam in operation. However, when the beam is on the bending test, there is a sagging and hogging moment in the beam, the bottom layer is under tension and the top layer is under compression. Since SCM works well on tension much better than conventional concrete due to the addition of fiber, thus the rehabilitated beam was placed to bending test so that the SCM layer was at the bottom to improve the efficient use of costly SCM.

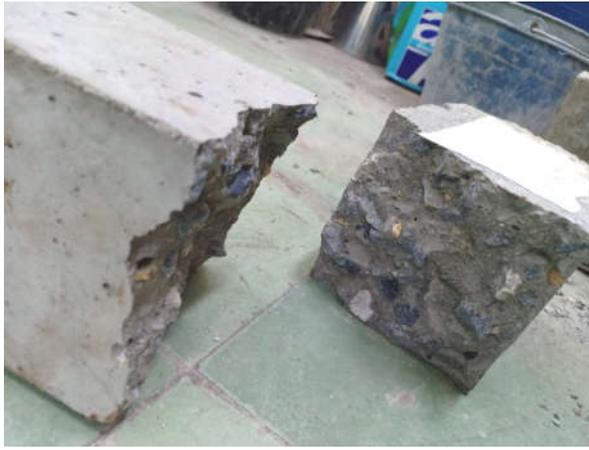
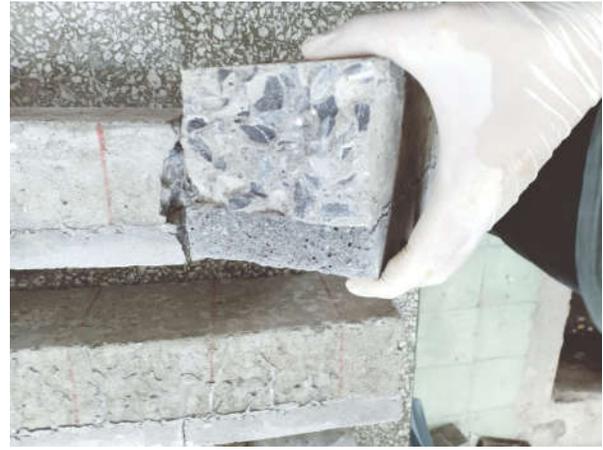
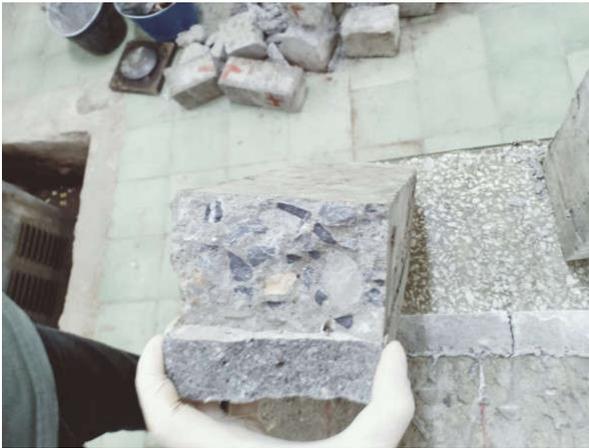
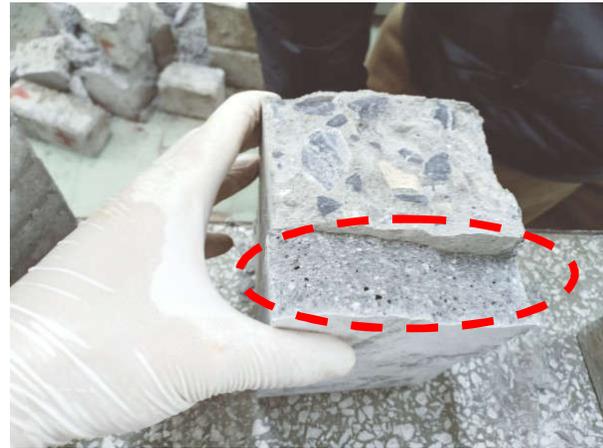
Visual observation on the non-rehabilitated and rehabilitated beam cross-section after the third-point bending test, as shown in Figure 9, depicts the next two points. Firstly, the failure mode of the non-rehabilitated and rehabilitated beam was similar, as it is seen that the main crack was developed up to failure in the middle

third of the beam, where it receives the maximum bending moment. Secondly, regarding the rehabilitated beams, there is no crack between conventional concrete and SCM, even though there was a cold-joint, as SCM was cast onto the conventional concrete when it had hardened before. In case of precracked beam before rehabilitation, the rehabilitated beam failed at the same crack that has been appeared previously.

a) Non-rehabilitated beam

b) Beam rehabilitated by the as-cast surface

c) Beam rehabilitated by the surface prepared with steel brush

d) Beam rehabilitated by the surface with hole-connector

Figure 9. Failure modes after the third-point bending test

It is remarkable to note that in case of the rehabilitated beams of surface with hole-connector, there was a slight delamination between conventional concrete and SCM at the location amid adjacent holes, as it can be seen in Figure 9d. The main reason might be due to the distance between the holes was too short and the drilling process has caused microcrack at the bottom of the hole. Besides, the hole diameter of 5mm seemed to be small, SCM could barely have penetrated into the substrate conventional concrete. This is an explanation for why the outcome of this rehabilitation method yielded the worst result in comparison with the other two methods.
