INITIATIVES ON ENGINEERING SOLUTIONS FOR CUA TUNG AND THE NORTHERN BEACH OF THE ESTUARY IN QUANG TRI PROVINCE

Abstract: Cua Tung estuary is one of the largest estuaries of Quang Tri province in Central Vietnam. The beach here is beautiful and well-known for tourist in the past. But it has been eroded thus reducing tourist attraction. Cua Tung estuary serves as an important waterway, flushing out floodwater from Ben Hai river to the sea. The complexity of hydrodynamic regime in Cua Tung estuary and vicinity area is a main driver to cause high variation on erosion and sedimentation. Erosion occurs in the north beach area leading to reduction of open space for tourist, meanwhile deposition accumulates in the south beach area of the Cua Tung estuary. The paper provides some initiatives on engineering solutions for Cua Tung estuary area and rehabilitating measures in the northern tourism beach of the estuary.

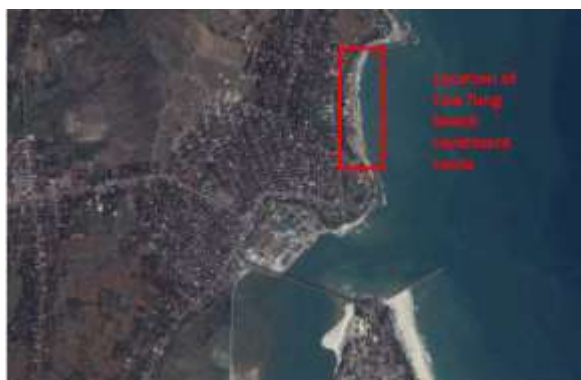
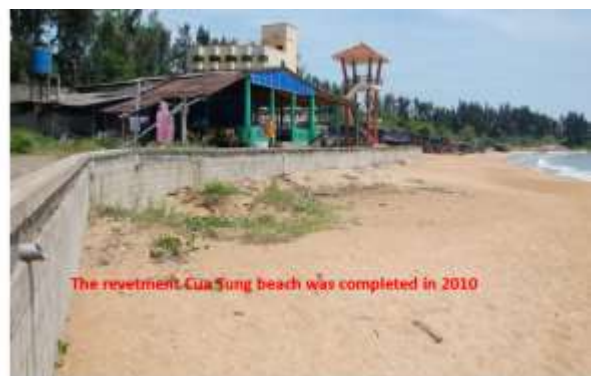
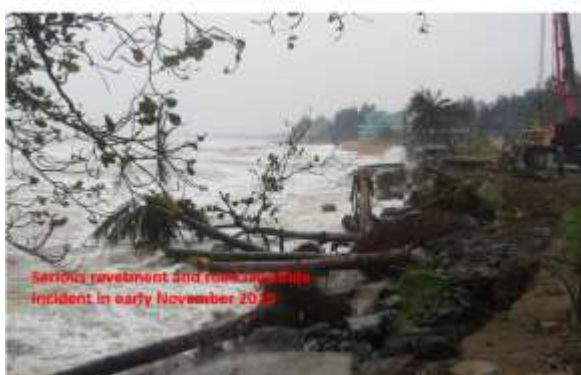
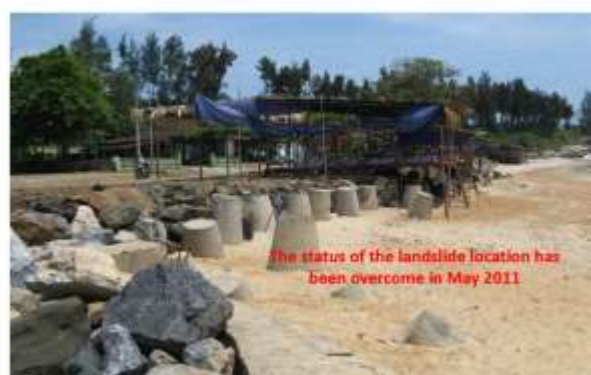
Figure 1: Incident of bank and revetment wall erosion at Cua Tung beach in 2010

structure. The revetment starts from a populated area (the rocky headland close to the mouth of the Ben Hai river), to the revetment of the marina (Figure 1). In November 2010, due to the impact of high tide, large waves caused subsidence and damages to 200 meters of the revetment, broke the asphalt road along the coast. In order to cope with the emergency situation, the Quang Tri province mobilized available resources to quickly overcome the consequences by pouring rocks to mend the damaged roads and arranging protection with Tetrapod concrete blocks [3]. However, due to the unreasonable design of these structures, they has certain effects on the beauty of the beach area, limiting tourism activities in the area.

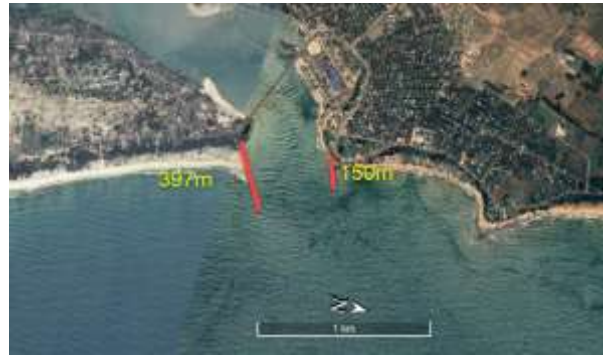
Figure 2: Jetties at north and south sides of Cua Tung estuary

The jetty was built in 2004, with the length of 430m, the height of 1.5m, the width of 6m with a structure made of stone and reinforcement stretching to the sea (Figure 2) for the purpose of breaking waves, blocking sand, reducing erosion of Tung Luat bridge piers and reducing deposition inside Cua Tung estuary to enable navigation and maritime for Cua Tung fishing port.

The northern jetty has a length of 150m stretching from Thua Luong cape (near the Border Guard station) to the sea and parallel to the jetty in the south side of Cua Tung. The northern jetty has a core structure made of poured stone with 3 layers of different sizes: The bottom layer in contact with natural soil is layer D4 with a thickness of 20cm, the size of stones is from 10-15cm. Next is the core of the rock dike D3 with the size of 10-30cm. The outer cover is a layer of 80cm thick D2 stone with the size of 40-50cm. On the top of the jetty there is a rock layer with 20cm thickness.

The top surface of the dike is 4m width, paved with 60cm thickness of M300 reinforced concrete slabs, around the roof and toe of the dike reinforced with 2 layers of Tetrapod T2 (2.5T) and T1 (4.2T).

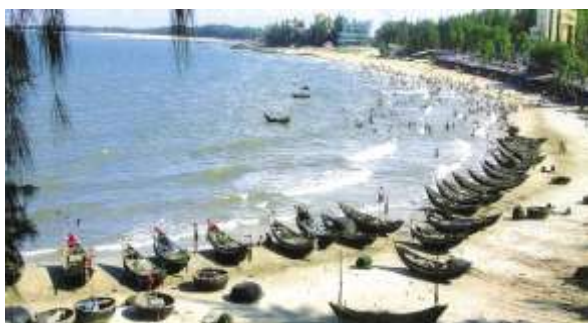
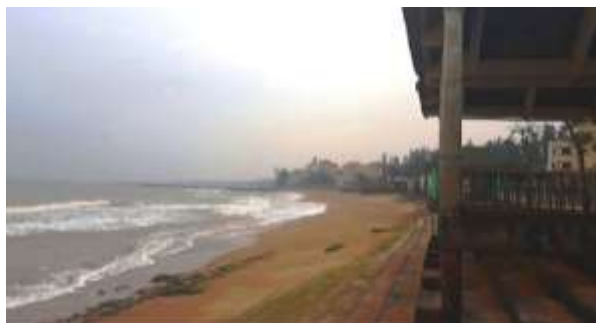
Figure 3: Cua Tung beach before and present

In recent years, the northern beach of Cua Tung has been narrowed due to increasing erosion in both scale and intensity. From the hundreds of meters width of white-gray sand beach with a gentle slope, now the width is only about 20-30m and the slope of the beach has increased dramatically, thus reducing drastically the number of tourists coming to this beach (Figure 3).

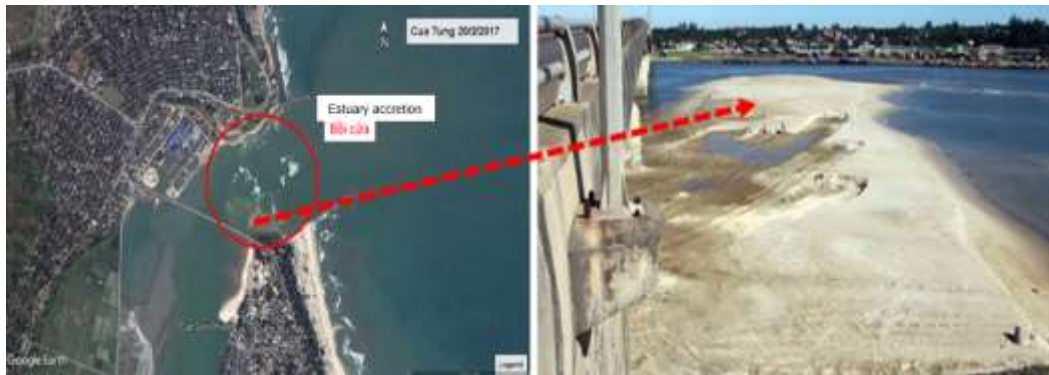
Figure 4: Deposition at Cua Tung estuary

Historically, Cua Tung estuary has always tended to be deposited. The strong development of sand dunes on the south bank of the mouth moving to the north has greatly affected the ships and boats go in and out of the Cua Tung estuary (Figure 4). To improve that situation, a 350 m length southern jetty

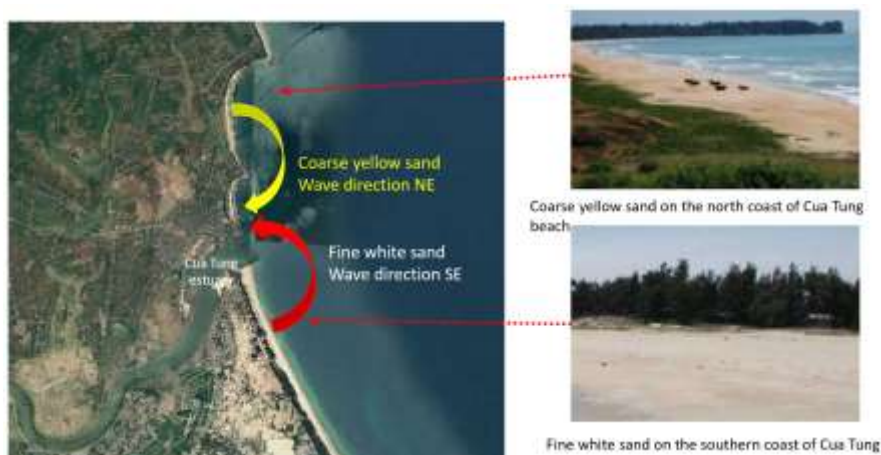
Figure 5: Diagram illustrating the mechanism of sediment transport in Cua Tung beach area

The sand at northern Cua Tung beach was previously supplied by 2 sources: one source from the upstream north coast brought down in the northeast wave (NE), this sand source has yellow color, and coarse; an other source from the south coast raised in the southeast wave (SE), this source of sand has white color, and smooth [2]. However, after the construction of a jetty at southern bank of Cua Tung estuary, the beach in the northern bank was almost no longer supplied with sand from the south bank, leading to a shortage of sand (Figure 5).

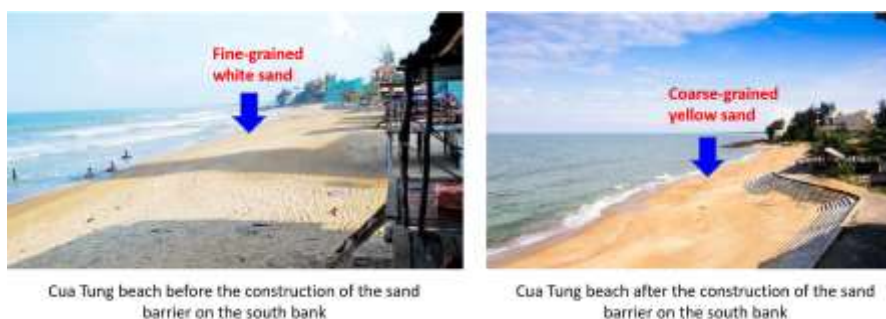
Figure 6: Sand at Cua Tung beach before and after construction of jetty dike on the south bank (white fine sand on the left, yellow coarse sand on the right)

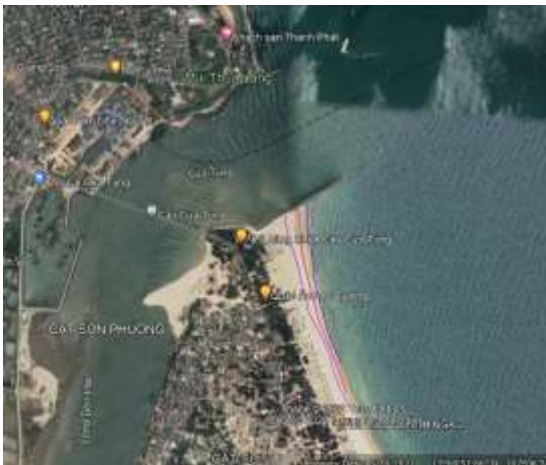
Figure 7: Accumulation at southern beach of Cua Tung from 2010 to 2020

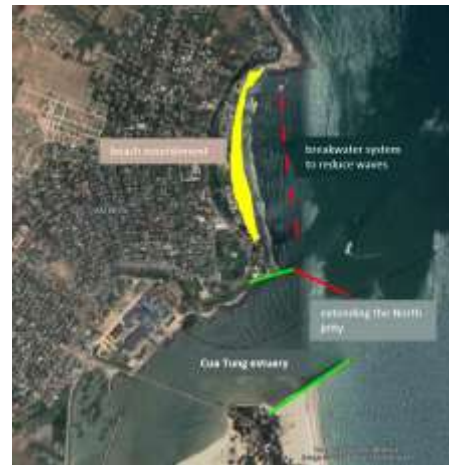
Figure 8: Orientation of the overall engineering solution of Tung estuary

- Building a system of breakwaters to reduce waves in combination with beach nourishment to restore and embellish the northern beach of Cua Tung.

- Lengthen the northern jetty and narrow the gap width between the 2 jetties to limit waves and mud entering from sides into the estuary;

- Periodically nourish sand to northern beach of Cua Tung in order to prevent sand loss. Sand source for nourishment can be taken from south side of Cua Tung.
