Neurological complication after vertebroplasty using bone cement: A case report

Vu Dinh Nam¹, Do Manh Thang², Dang Viet Son², Vu Thi Phuong Thao¹

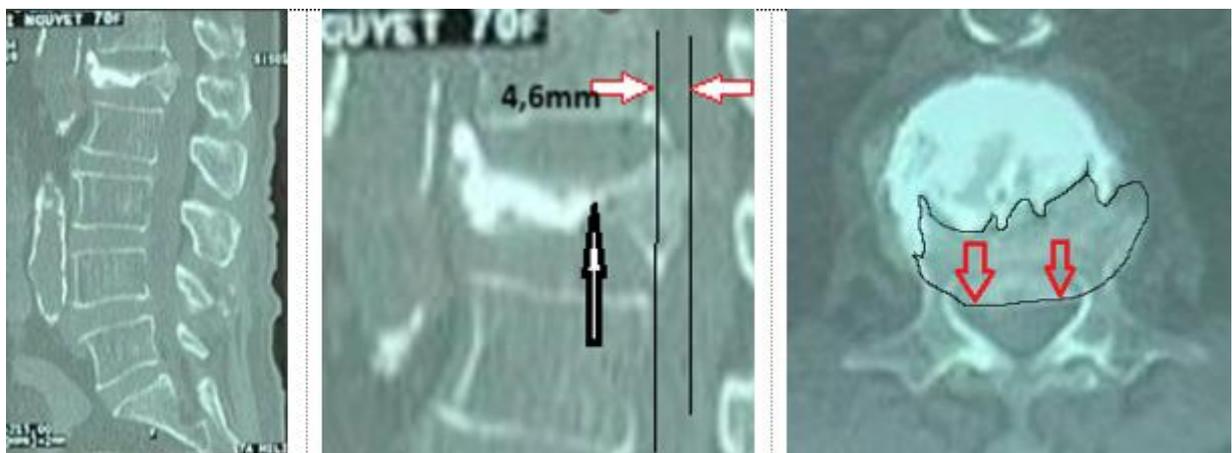
Figure 1. CT imaging showing grade 3 L1 compression fracture. The middle column is disconnected from the anterior column at the black arrow, posterior displacement of the middle column by 4.6 mm (red arrow), causing canal stenosis.

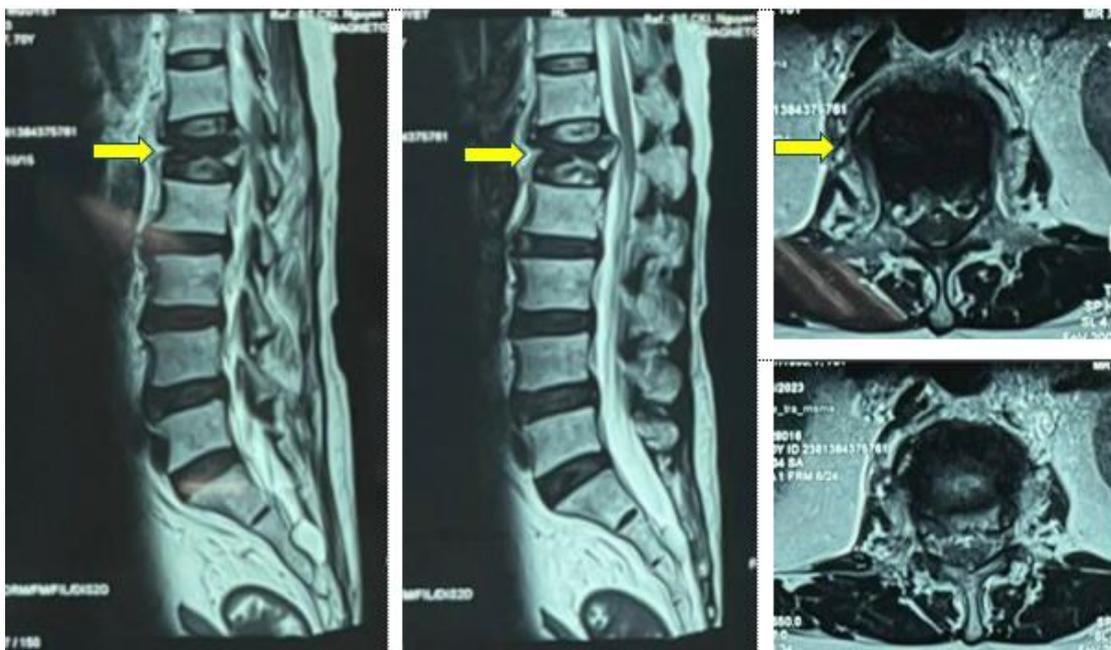
Figure 2. Sclerotic fracture line and posterior wall compressing the spinal cord on MRI (yellow arrow); no posterior longitudinal ligament hypertrophy
